**PART DESIGN, CONSTRUCTION, OPERATION & MAINTENANCE (For
a Period of 5 Years) OF FULLY AUTOMATIC MULTI-LEVEL CAR
PARKING SYSTEM AT CENTRAL CIVIL SECRETARIAT, ITANAGAR,
ARUNACHAL PRADESH**

**VOLUME 8
GEOTECHNICAL REPORT**

FIELD TEST REPORT

PROPOSED MULTISTOREYED PARKING

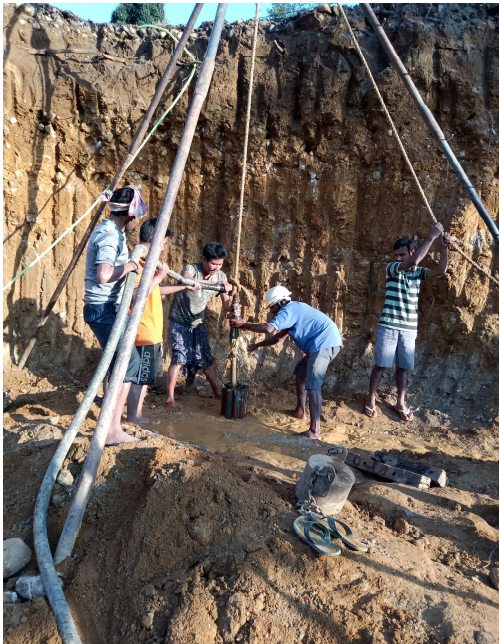
Fig-2.0 Boring in Progress,

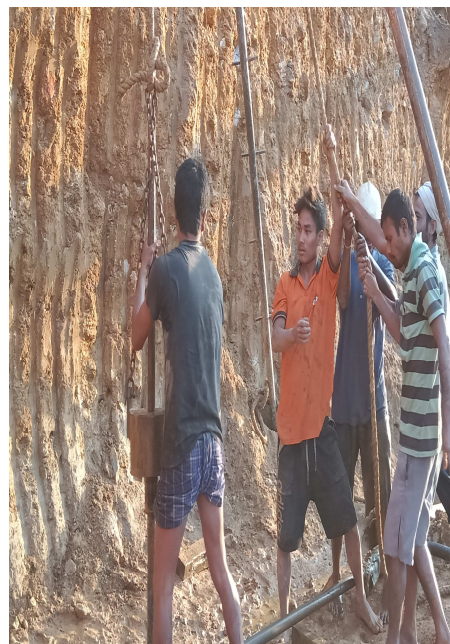
Fig-2.1 SPT arrangement in Progress

Standard Penetration Tests (SPT)- Standard Penetration Tests were conducted at each 1.50m interval or where significant variations in soil strata were observed. Standard Penetration Tests were carried out using a split-spoon sampler as per IS: 2131-1981. A drive weight of 63.5kg drop hammer for a free fall of 75cm was used. Number of blows required to drive the sampler for first 150mm was neglected. The sampler is further driven to a depth of 300mm or 100 blows. The number of blows required to affect each 15cm of penetration was recorded. Total blows required for the second and third 15cm of penetration was termed the penetration resistance (observed N-value).

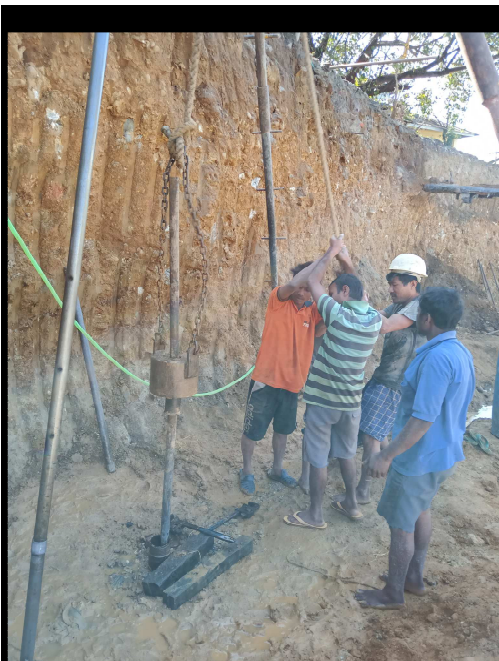
Fig-2.2 SPT in Progress

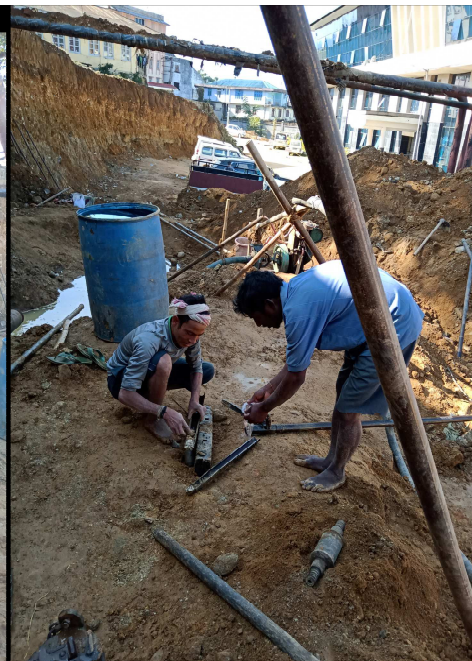
Fig-2.3 SPT sample collection
